# MOTORCYCLE ROAD SAFETY AUDIT CASE STUDIES

**Making Your Roads Safer**  
FHWA-SA-16-026

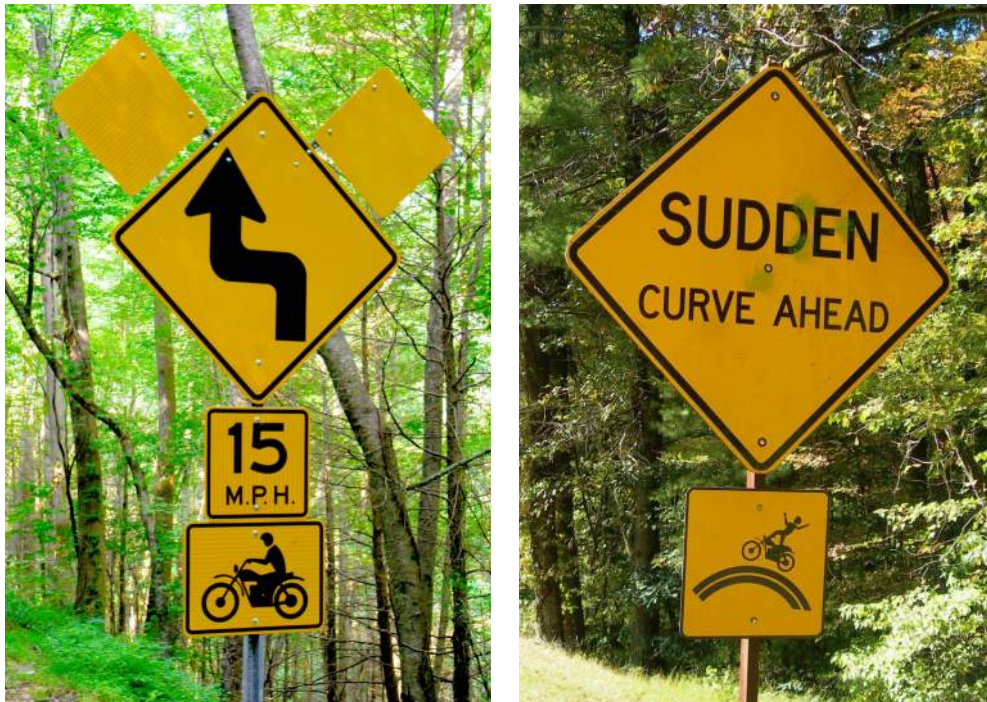
**Left:** NCDOT installed signage on North Carolina State Route 28 that includes curve warning signage, flagging, and a supplemental advisory speed plaque in addition to the motorcycle-specific supplemental plaque (Credit: Dan Nabors). **Right:** The “motorman” supplemental motorcycle plaque, which is not MUTCD-compliant, on the Blue Ridge Parkway (Credit: NPS).

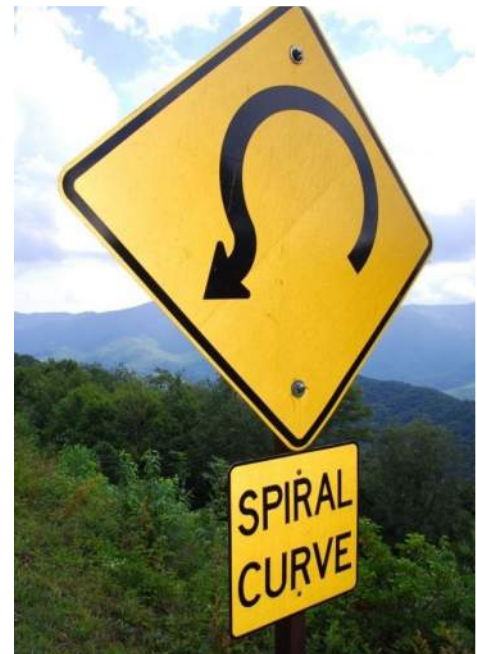
*A Spiral Curve Warning Sign. Note: sign not MUTCD-compliant. (Credit: Dan Nabors)*

*Installing warning signs depicting unusual conditions.* The National Park Service developed a warning sign with a “SPIRAL CURVE” placard and deployed it on spiral curves on a downgrade to alert all roadway users of a condition that may violate driver expectation. This may be particularly helpful messaging for motorcyclists, who must maintain balance while maneuvering through a curve.

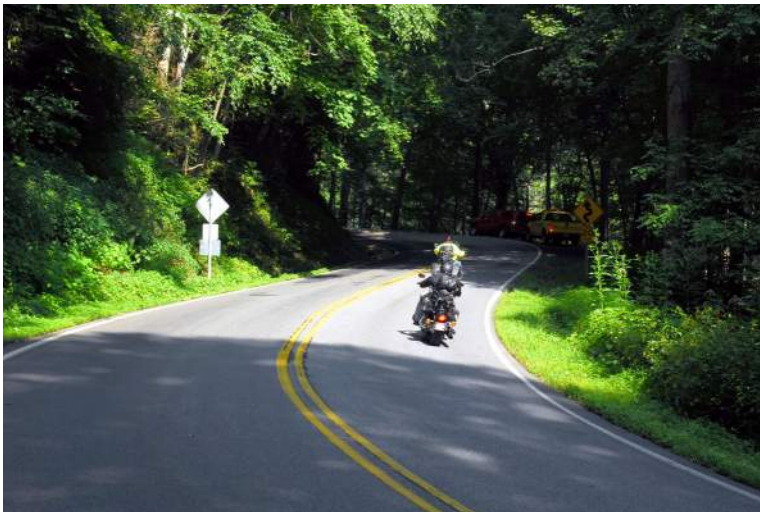
***Sudden changes in lighting on the roadway, particularly when motorcyclists are wearing sunglasses, may cause motorcyclists to lose visual path of the roadway. (Credit: Dan Nabors)***

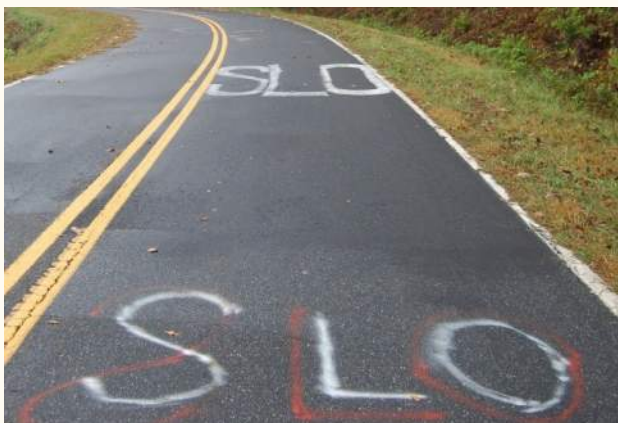
*Example of information applied by road users to provide a variety of conditions. (Credit: NCDOT)*

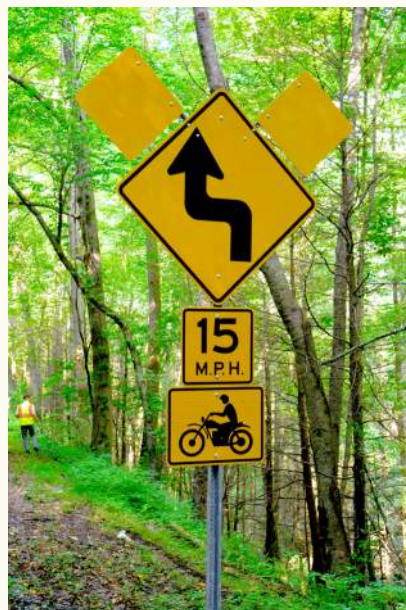
*Signs implemented by NCDOT at study location. (Credit: Dan Nabors)*

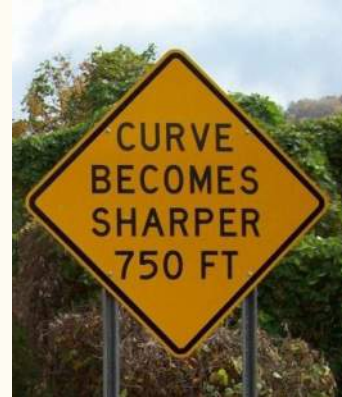
*Example of sign implemented by NCDOT in other locations. (Credit NCDOT)*

- Trim vegetation to maximize sight distance.
- Explore opportunities to employ alternate signing or pavement markings to warn of impending compound curvature and sag or crest vertical curves.

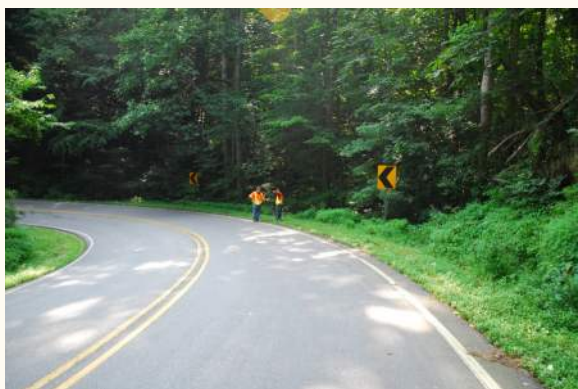
Similar issues to northbound direction. The visibility of the chevrons is affected by the shading created by the canopy and their number, spacing, and placement (see photo below).

*View approaching series of curves on southbound NC 28. (Credit: Dan Nabors)*

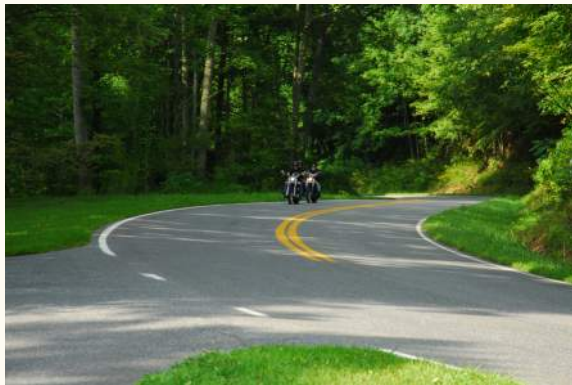
- Change in the roadway canopy – the pull-off is in an open section.
- No advance warning of curve or pull-off.
- Potential distractions include the scenic view and slowing or stopping vehicles.

*Photo of the easternmost access point. (Credit: Dan Nabors)*

- Install advance warning signs indicating the presence of an overlook (Skyway signage).
- Designate overlook with name and milepost.
- Encourage law enforcement to use mileposts in crash reporting.
- Reduce gap in centerline markings with hash markings (see photos; each access already has edgeline skip markings) to help riders maintain visual focus of the roadway curvature.
- Due to lack of cell phone service, investigate feasibility of installing a call box at this location to allow for more timely crash reporting and EMS response. Keep in mind that a landline hookup would not be available.

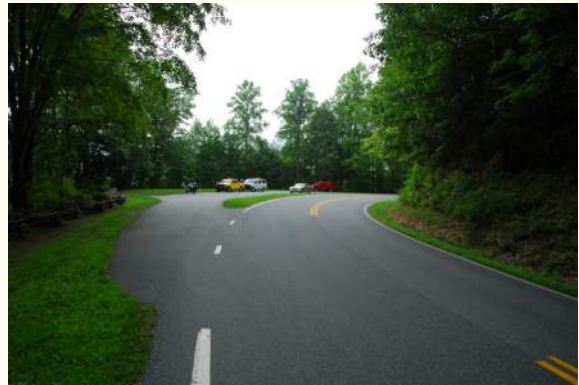
*Photo of the westernmost access point. (Credit: Dan Nabors)*

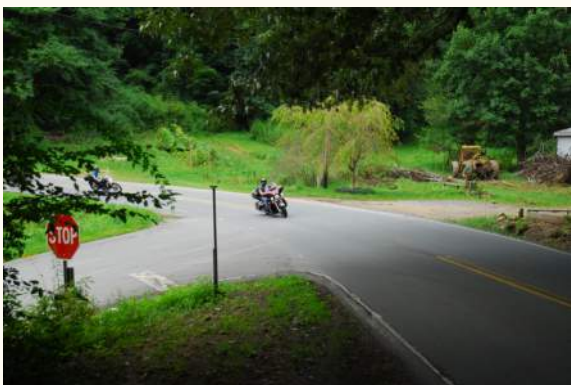
- Possible dragging floorboards and overcorrecting.
- Large gap in pavement markings.
- Presence of intersecting roadways.
- Presence of gravel shoulders.
- Worn centerline markings, indicating vehicles/motorcycles crossing the centerline.

*Photo showing motorcyclist crossing centerline on a sag vertical curve and horizontal curve. There is an intersecting roadway and driveway within the curve.  
(Credit: Dan Nabors)*

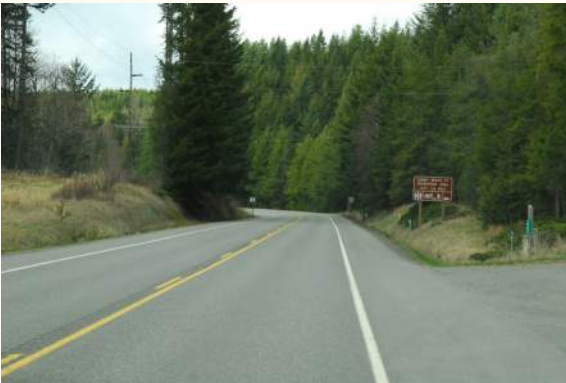
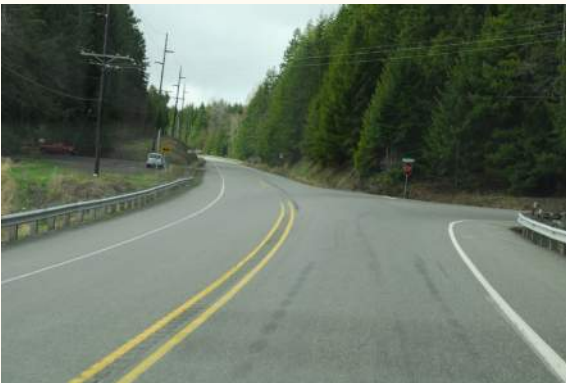
- There were seven (7) crashes at this intersection.
- Approximately two-thirds occurred at or were related to a driveway or intersection. Drivers may not expect to encounter vehicles entering or exiting driveways in this area.

*Top photo: Northbound on SR 7, near two private driveways, and heading towards the intersection with Alder Cutoff Road. Bottom photo: View of northbound on SR 7 at the intersection with Alder Cutoff Road and showing the parking area to the left. (Credit: Dan Nabors)*

- Remove vegetation from inside of curve and near driveway/intersection to improve sight distance.
- Provide additional intersection/driveway delineation and warning.
- Combine wayfinding and safety education materials, such as scenic route maps that include motorcycle safety information.
- Consider warning signs depicting the roadway alignment and road/driveway intersections. If additional warning is needed, beacons can be added to the warning signs.

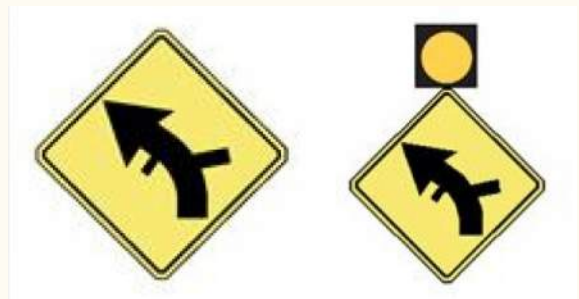
*Examples of intersection warning signs that depict the location of intersections along a curve. The sign on the left is an example of sign that could be used for northbound drivers on SR 7, as it depicts the intersection with Alder Cutoff Road on the right, and the parking lot entrance on the left. Consider combining the warning sign with a flashing beacon, as shown.*

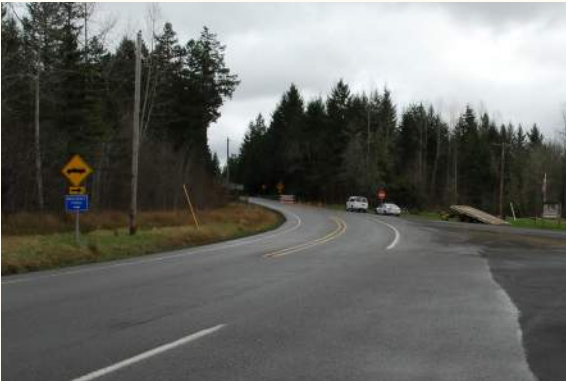
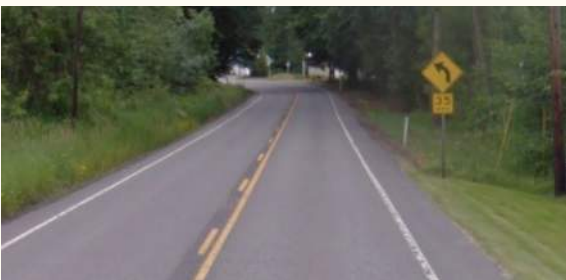
- There were 12 crashes at this location. Most of the motorcycles were traveling in the southbound direction.
- Superelevation
  - » The RSA team noted a difference in the superelevation between the curve at the intersection of SR 7, Tanwax Road, and 66th Avenue and the curve to the south of the intersection. The curve at the intersection was noticeably flatter than the curve to the south.
  - » The RSA team measured the superelevation, with readings varying from 0.9 to 2.6 degrees.
- Delineation
  - » Gap of pavement markings and center line rumble strips at intersection with two roads
  - » Lack of delineation of intersecting roads/island
  - » Lack of curve delineation

**Top: Southbound view of the curve at the intersection of SR 7, Tanwax Road, and 66th Avenue. This curve is fairly flat, particularly in comparison to the curve to the south. Bottom: Southbound view of northern curve, at the intersection of SR 7, Tanwax Road, and 66th Avenue. This curve warning sign is the only one used on the curve in either direction. There are also a couple post-mounted delineators. (Credit: Dan Nabors)**

- Remove vegetation on inside of curve to improve sight distance.
- Evaluate superelevation of curve through a ballbank test.
- Provide additional curve delineation and warning through the use of warning signs indicating the location of the intersection (in both the northbound and southbound directions), reflective post mounted delineators that are evenly spaced throughout both sides of the curve, and dotted edgeline through the intersection. Additional positive guidance could be provided through wider 6-inch edge and centerlines.

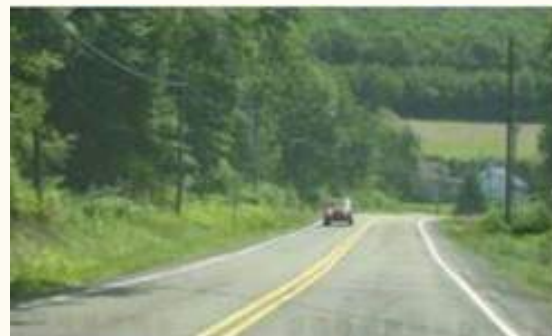
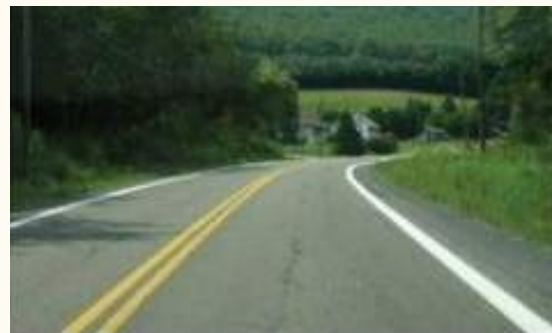
**4-inch edge and center lines (top). Wider 8-inch edge and center lines (bottom). (Credit: FHWA)**

- Consider applying wider edge and centerlines and shoulder rumble strips.

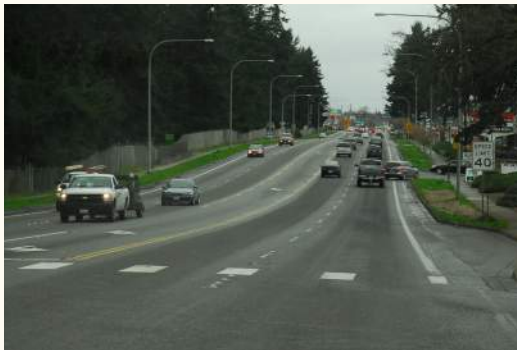
- Changes in cross section may lead to improper lane positioning and changing of lanes.
- Wide outside lanes may encourage higher speeds.
- Shoulders of varying width, which may result in their use for unintended purposes such as stopping.
- Varying cross-sections may cause unexpected shifts in alignment.
- Vehicles parked on the curb or next to intersections and driveways limit sight distance between the road and intersecting streets and driveways. On-street or curb parking increases friction between vehicles in the travel lane and parked vehicles.

**SR 7 near the intersection at 159th street: a wide edgeline separates the vehicular travel lanes from the bike lanes. The edge lines are not present or are much narrower on the northern portion of the corridor. (Credit: Dan Nabors)**

- Provide consistency in the corridor through pavement markings or raised pavement markers that define travel lanes.
  - » This can be combined with an access management plan, explained on the following page.

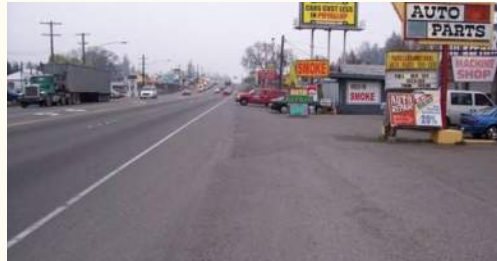
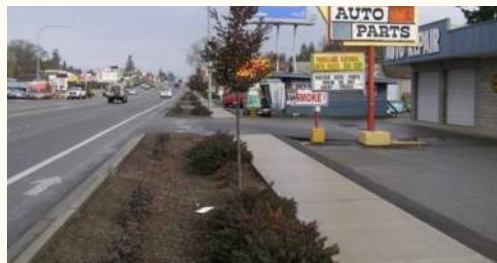
**Photo top: SR 7 before implementation of access management. Photo below: the same location on SR 7 after access management implementation (Source: Analysis of Access Management Implementation: A Success Story, WSDOT). The access management project helped provide consistency in roadway cross section by defining the lanes with additional pavement markings and curb.**

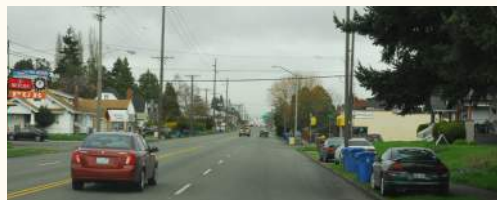
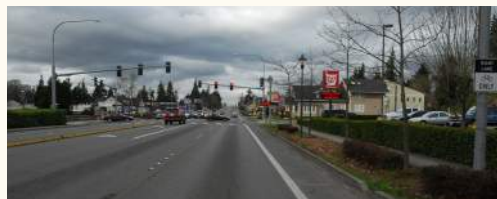
**A section of SR 7 near 43rd street. The wide outside lane may encourage higher speeds. Traffic parked on the curb limits sight distance between the road and intersecting streets and driveways. Investigate the reason vehicles are parking on the curb. (Credit: Dan Nabors)**

Review parking regulations to provide consistency in where to locate parking and how to define those areas with parking using pavement markings and signage. Changes to the parking policies may help to reduce or eliminate friction between vehicles in the travel lane and those utilizing the parking.

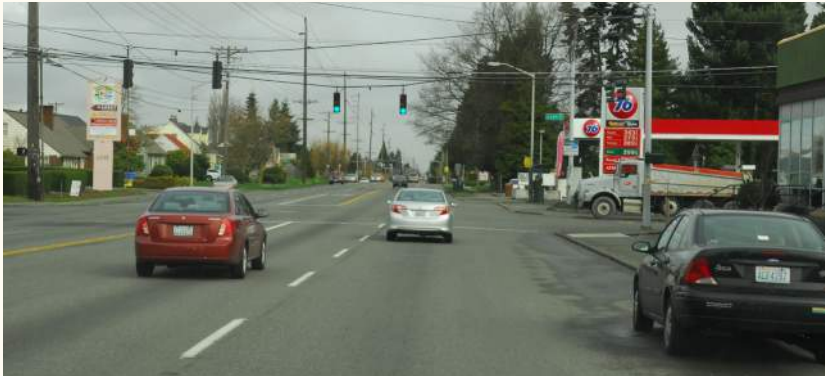
*Top: Section of SR 7 near S 64th Street where the road transitions from a section with unmarked, on-street parking to a narrower section no on-street parking. The parking is not defined with an edgeline, creating a wide outside lane that may encourage unintended maneuvers and speeding. (Credit: Dan Nabors) Bottom: Example of pavement markings that could define on-street parking. The markings can be used to restrict parking near driveways and intersections, improve visibility of intersections, and define parking so that there is a consistent cross-section throughout the corridor. Signage can be used to restrict parking during times of day when crashes are more prevalent (e.g., 2 PM to 7 PM). (Source: Google Maps)*

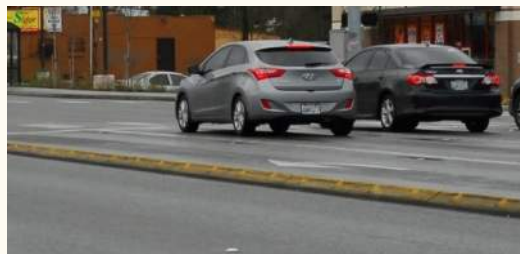
*Example of an existing barrier on SR 7. (Credit: Dan Nabors)*

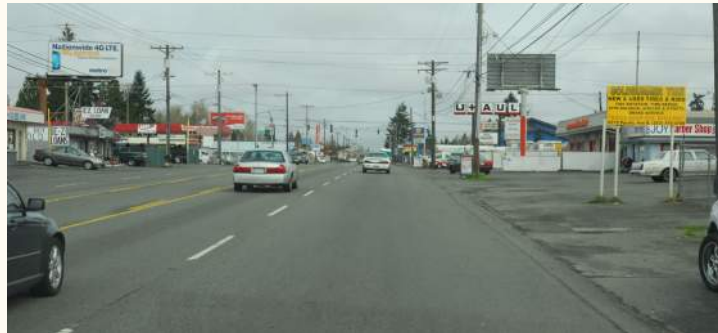
*There are portions of the corridor with wide-open accesses. Wide accesses, like the one shown above, increase the potential for conflict. Creating discrete access points would reduce the number of conflict points and would increase drivers' expectancy. (Credit: Dan Nabors)*

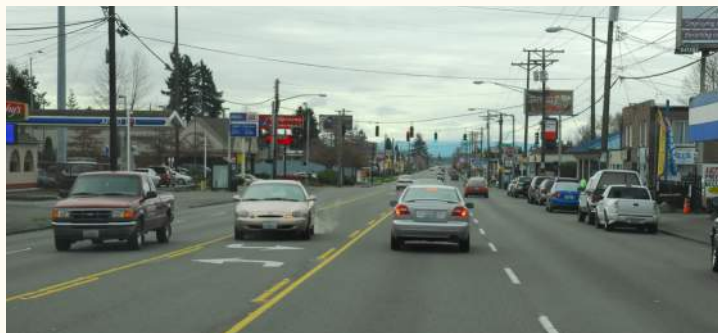
*A section of SR 7 near 84th Street. There are multiple points of conflict in this section of the corridor, including left-turning vehicles from the two-way left-turn lane, traffic in the unmarked parking lanes, and vehicles entering from side streets and driveways. (Credit: Dan Nabors)*

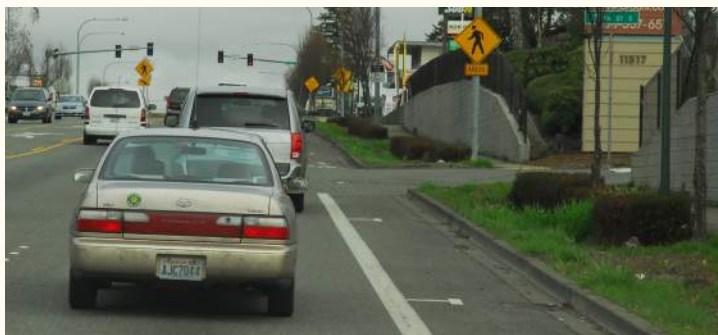
*Near the intersection of SR 7 and 116th Street, there are several intersections and driveways with limited sight distance due to the retaining walls and change in elevation. The limited sight distance increases the risk in this location, where there are numerous conflict points as drivers turning left from side streets or driveways cross sidewalks, bike lanes, four travel lanes, and a two-way left-turn lane. (Credit: Dan Nabors)*

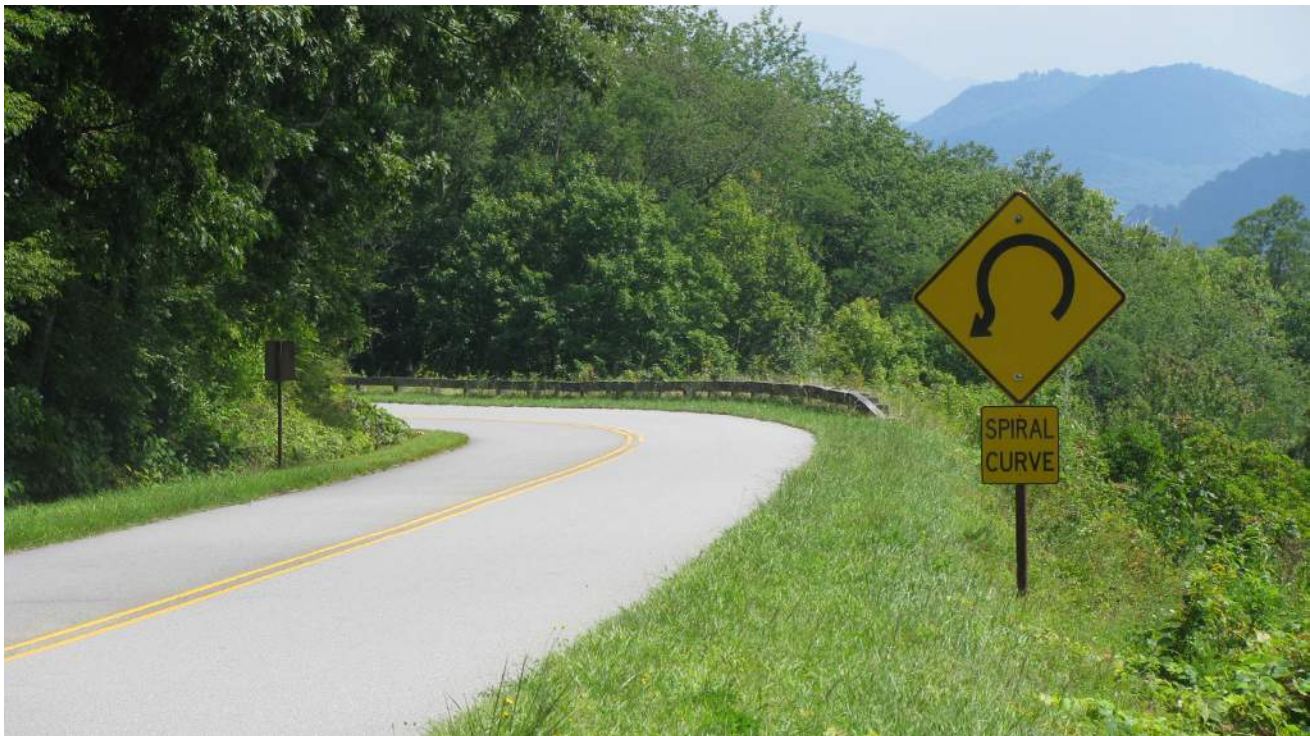
In response to the high number of crashes involving motorcycles and crashes on curves in general, BLRI staff implemented a signage program to address vehicle speed and loss-of-control crashes on curves with a descending radius – that is, “spiral curves.” The signage program entails installation of unique messaging intended to provide drivers with advance warning of the curvature in the roadway. The signs are comprised of a 48x48-inch aluminum yellow warning sign displaying a black rounded arrow indicating the direction of curvature and a supplemental yellow placard with a black “SPIRAL CURVE” message.

*Spiral Curve Warning Sign along the Blue Ridge Parkway. (Credit: Dan Nabors)*

Installation of the spiral curve warning signs started as a one-year pilot in 2001 and targeted locations along descending grades in mountainous sections of the parkway. NPS has continued to install additional signs and has 15 signs at different locations on the parkway. BLRI staff have been measured in their use of the signs, both to avoid diminishing the effectiveness of the signs through overuse and to avoid significant impacts to the cultural and historical character of the parkway.

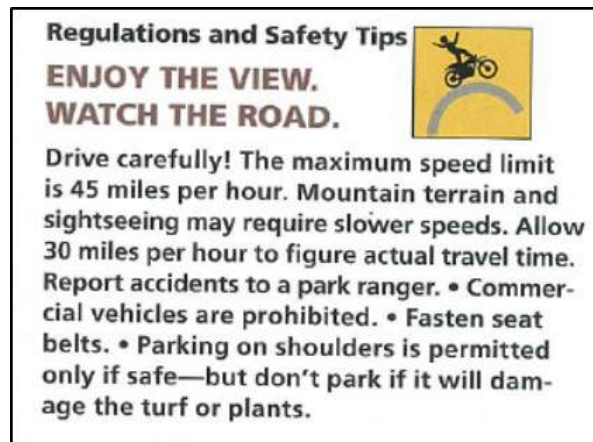
Figure A-10: Excerpt from Blue Ridge Parkway Brochure Illustrating the “Motoman” Sign. (Source: NPS)

BLRI staff have also developed motorcyclist-specific signage. The “motoman” sign was developed and used by the park in locations with a high incidence of run-off-the-road motorcycle crashes (Figure A-10).

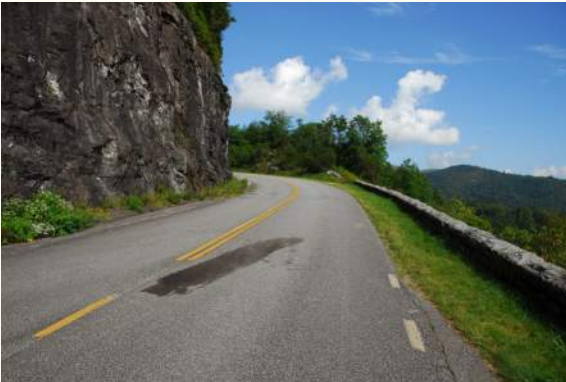
*A fluid spill near mile marker 418. Fluid spills can contribute to loss of control crashes for motorcycles. This is particularly critical at this location due to horizontal curvature and limited sight distance. (Credit: Dan Nabors)*

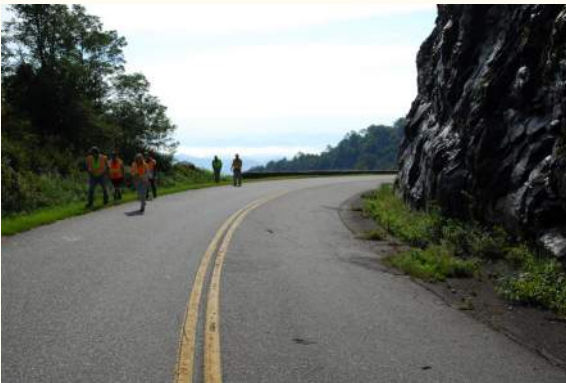
*The pavement has been damaged by fallen rock and the roadway width is impacted by the encroachment of vegetation. (Credit: Dan Nabors)*

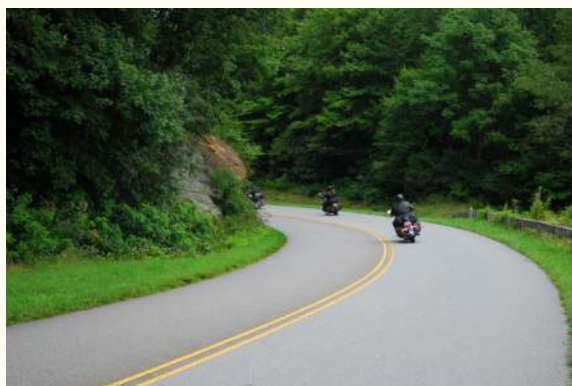
*Motorcyclists exhibit a range of riding behaviors. In this photo, the last motorcyclist is riding very close to the centerline around a curve with limited sight distance. (Credit: Dan Nabors)*
